An Experience of the Conservation of Historic Buildings' Facades in Old Saida City

Jad Hammoud¹

¹ Faculty of Fine arts and Architecture, Lebanese University, Lebanon

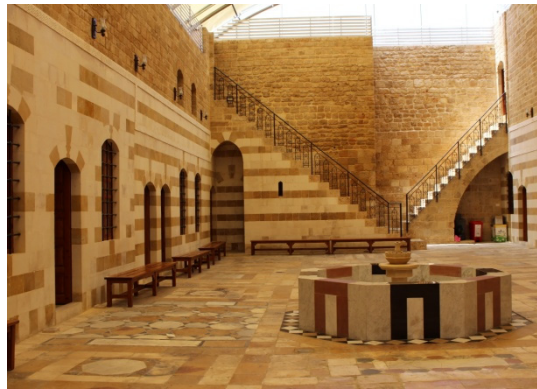
Figure 2. Courtyard located on the first floor level (Hammoud J., 2019)

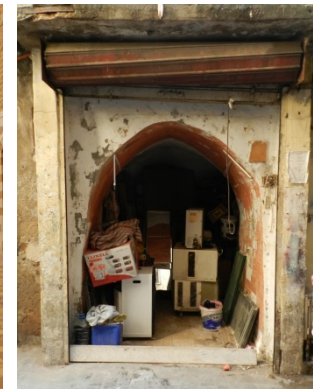
Figure 3. Vaulted substructures at ground floor level used as shops (Hammoud J., 2019)

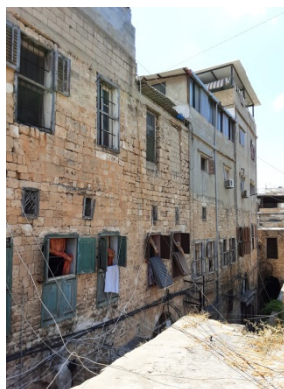
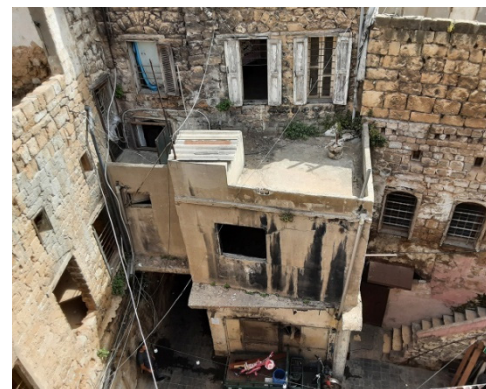
Figures 4, 5, 6 & 7. Poor conditions and damages of the facades, deterioration of the original building materials like lime plaster, timber windows, and aesthetic degradations (Hammoud J., 2022).

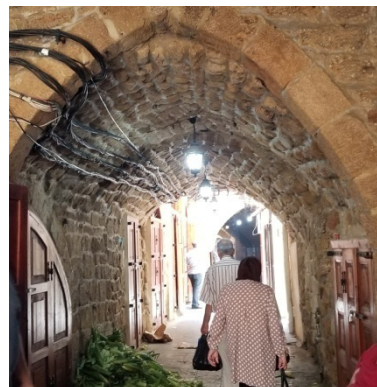
Figure 10. *Subat* is a shed between two walls with an accessible passage, suitable for the passengers and caravans.

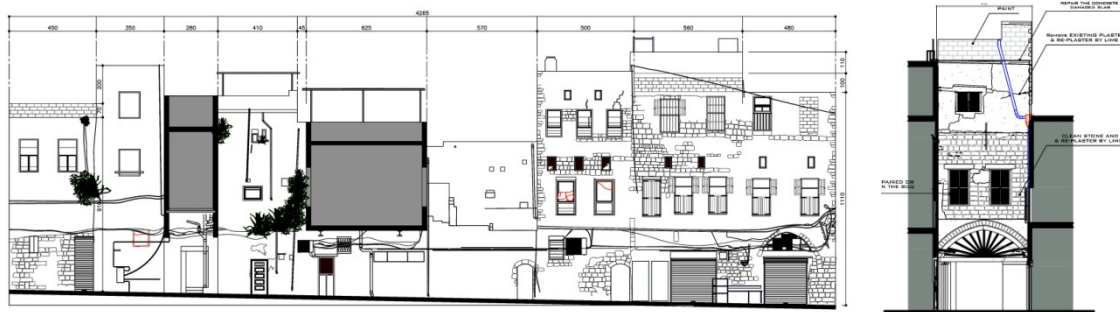
Figure 12. Architectural drawings recording the existing situation of the facades in Musallabiyeh old market street (Hammoud J., 2022).

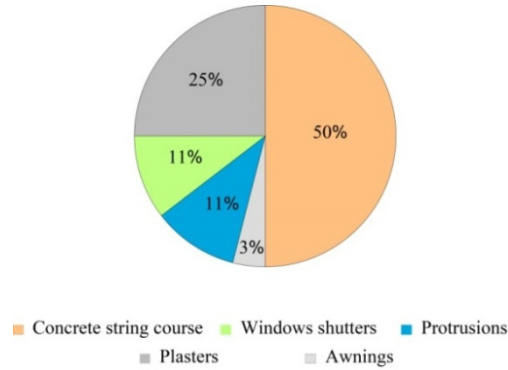
Figure 15. An assessment showing hazardous risk percentage (Hammoud J., 2023).

In the planning process, the presence of hazardous elements such as balconies, windows shutters, string courses, plaster, protrusions, cornices, and awnings requires a comprehensive approach that prioritizes safety without compromising the architectural integrity and historical significance of the facades (Figure 15). The process begins with a thorough assessment of each element's condition, identifying potential risks and vulnerabilities. Conservation specialists' team evaluates the stability, material deterioration, and structural integrity of hazardous elements, informing decision-making regarding intervention and rehabilitation strategies.

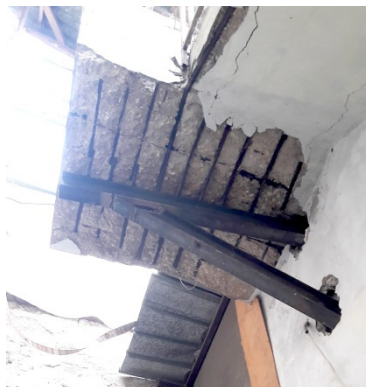
Figure 16. Balcony hazardous element in Furn el Saha square

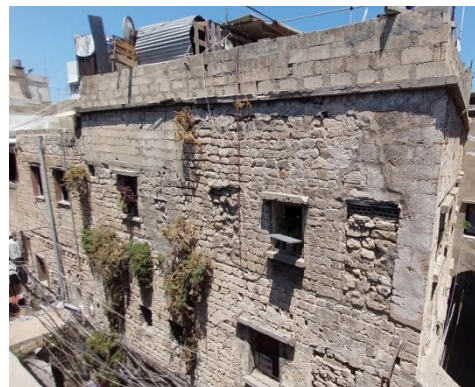
Figure 17. Deteriorated concrete string course and closed openings in the Musallabiyyeh market street

Mitigating risks associated with hazardous elements involves a combination of stabilization, repair, restoration, and, when necessary, selective replacement. More specifically, risk is most apparent in many structures in Furn el Saha square mainly due to illegal construction on top of existing buildings. Balconies and protrusions undergo structural assessments to ensure load-bearing capacity and stability, with reinforcement or restoration carried out using compatible materials and construction techniques (Figure 16). Windows shutters are inspected for decay or damage, with repairs undertaken to address structural weaknesses while preserving original features or replicating them as needed. In the Musalkhieh and Musallabiyyeh market streets, some of the façades are beginning to lean and in some instances have been bolstered with concrete additions by the local community. The addition of concrete balconies can be a contentious issue. While they may offer practical benefits such as increased living space and improved views, they can also pose significant challenges. Concrete string course at roof, plaster, cornices, and awnings are evaluated for signs of deterioration, such as cracks, decay and detachment. The author employs consolidation and replacement techniques to address damage while maintaining historical authenticity and visual continuity. Roof structures undergo thorough inspections to identify leaks, structural weaknesses, and weathering, with repairs or replacement conducted to safeguard against water infiltration and structural failure. Also the presences of elements, which may disfigure the traditional heritage values of the buildings, have been considered, such as addition of floors with inconsistent materials and closing of original openings (Figures 17&18).

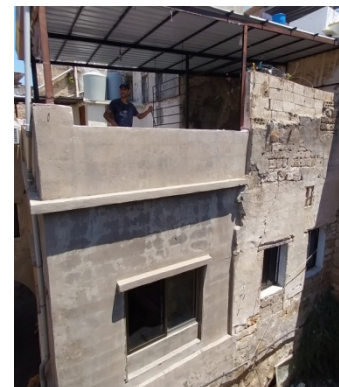
Figure 18. Addition of floor with inconsistent material in Musalkhieh street(Hammoud J., 2022)

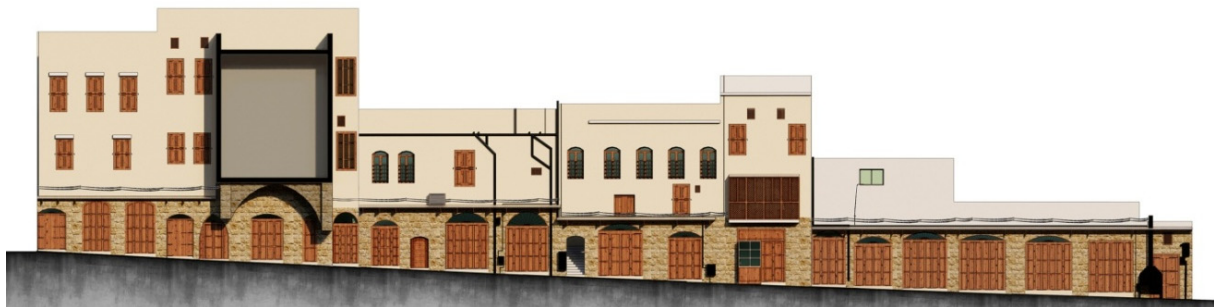
Figure 19. Design of the façade in Musallabiyyeh old market street involving a balanced blend of sensitivity and innovation. The design effectively differentiates the concrete parapet that is white in colour. The upper part of the façade is lime plastered while the market level is kept stone due to the local residents' request. The sanitary pipes are shown in black colour adding visual interest through contrast (Hammoud J., 2023).

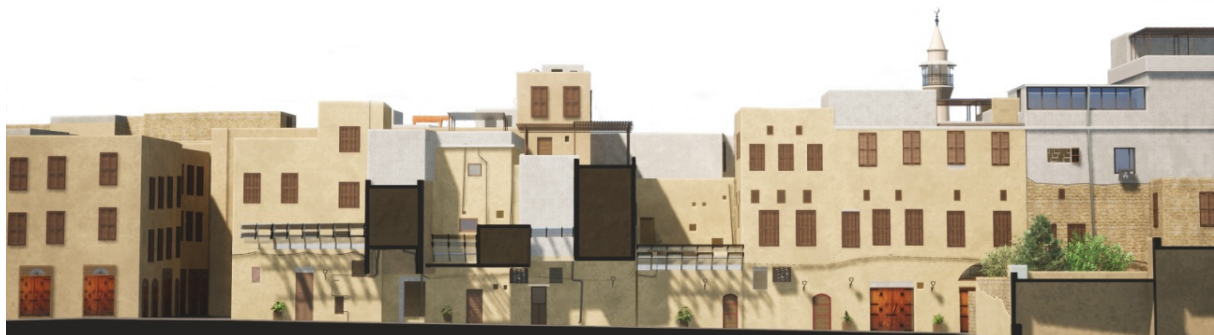
Figure 20. Design of the façade in Kaniset el Amercani street showing its overall historic character. Timber doors and windows are restored, walls are lime plastered and the existing additions introduce distinct visual elements to the concrete portions coloured in white (Hammoud J., 2022).

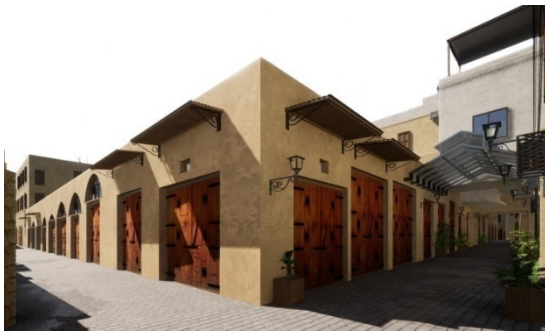
Figure 21. Perspective showing the design of the modern canopy that covers part of Kaniset el Amercani market alley blending seamlessly with the historic facade (Hammoud J., 2022).

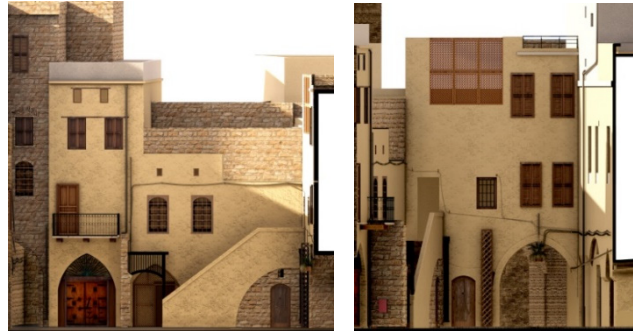
Figure 22. Design of the façades in Furn el Saha square. Timber doors, windows and *musharbiyyeh* are restored and walls address both aesthetic and functional concerns (Hammoud J., 2022)

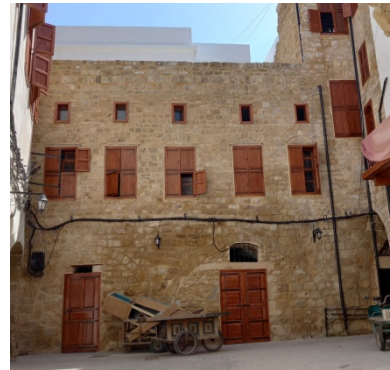
Figure 25. Cleaned stone façade in Furn elsaqa square (Hammoud J., 2022)

In some cases, cement material is used in the external coating in buildings. The difficulty of removing them varies enormously, depending on its condition, strength and how deeply it is applied to the surface. If the cement mortar is very deep it may be harder to remove, particularly if a strong mix was used. Traditional cleaning techniques are employed to remove accumulated dirt and grime by using chisels and hammers without causing damage to the original stone surfaces [6]. The chisels are tapped head gently to remove the existing and damaged cement layer plastered on the sandstone until it is exposed. In case where superficial dust and particulate matter are stuck on the stone, a simplest act of mechanical cleaning is used to physically remove the matter from the stone surface (Figure 23 & 24). There is no requirement that a machine is used and most mechanical cleaning is done by hand as the following steps [13]: 1. Trace the boundaries of the surface to work then cut the marked area with a chisel and a hammer to obtain a uniform cavity 15 mm deep surroundings. 2. Moisten the surface and apply with a trowel the mortar prepared to fill half the depth of the cavity. The mortar must be compact. 3. Water the surface. 4. Apply a second layer of mortar until it protrudes from the surface of the cavity. Reshape straight surfaces with a saw blade and those engraved with a fine chisel and a hammer. Cleaning should be performed from top to bottom, taking care to avoid using sharp tools when approaching the surface to prevent damage. No chemical interaction takes place. Before applying the lime plaster, the sandstone surface is washed by water and a soft brush is used to remove sedimentation (Figure 25).

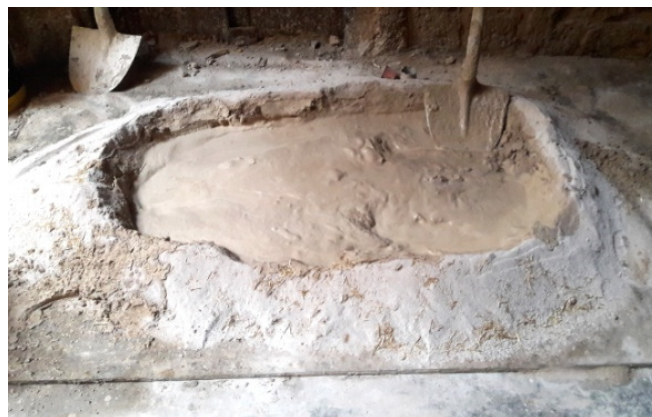
Figure 26. Lime mixture (Hammoud J., 2022).

2). Lime Plaster Application: Traditional lime plaster is meticulously applied to restore and protect the facades, ensuring compatibility with the original construction materials. Completing and repairing the mortar layers on stone walls is crucial. This layer acts as a protective skin on the surfaces of the stone walls, enhancing the cohesion of the wall stones and shielding the wall from various damaging factors like wind, sand, rain, salts, and biological damage [5]. The application process should involve multiple coats, possibly up to three. The first coat, known as the dubbing coat, provides a level surface that enhances the stability and cohesion of the subsequent mortar layers. This coat is the thickest, offering sufficient bonding to ensure the adhesion of the second coat. However, very deep hollows should be pinned to reduce the amount of mortar required. Allow the dubbing coat to set for 8-10 hours before scraping and keying it. These coats should be left rough to provide a good key, and it is preferable to use a rich mix with a binder-to-sand ratio of one part natural hydraulic lime NHL 3.5 to two parts 3-4mm grit sand. The normal thickness is between 3 and 5 mm. The second coat has to be applied four days after completion of first coat. Thickness will vary according to the overall thickness required but it is normally between 10 and 15 mm. It must not be over 20 mm thick. If this is required it should be done in successive coats each not exceeding 20 mm. The second coat should be put on with a wooden float and finished with circular strokes to leave a smooth, but not polished surface that helps a lot in leveling the surface. The thicker the intermediate coats, the longer the waiting time before each subsequent application. This coat consists of one part of lime to two and a half well graded sand [6]. Just before the mortar is applied, the straw should be added with a length not to be more than 1.5 cm (Figure 26). The third coat is the finishing coat which is usually a thin layer of 1 mm thickness. Mortars should be prepared by using the Non-Hydraulic lime which results in fat lime putty hardens (Figure 27). It consists of one part of lime to one and a half parts of good quality of building sand. This coat is applied after the drying of the second coat to eliminate the surface microstructures [6]. The best tool for applying the render is a square, slightly curved blade with no sides, on which the mortar may be scooped up, spread on the blade then hurled at the wall with the flick of the wrist.

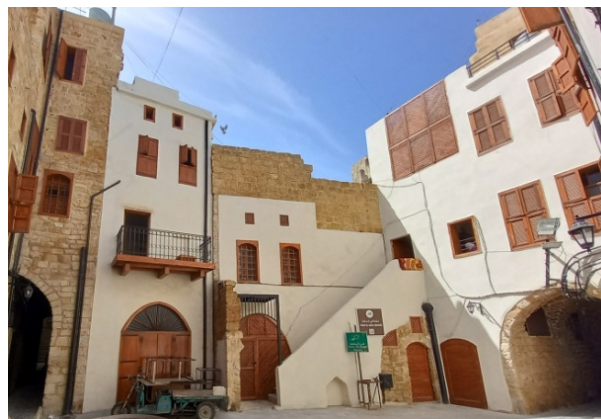
Figure 27. Applying three coats of non-hydraulic lime on the stone facade enhances the aesthetic appeal by showcasing its natural color. Each layer is meticulously applied, starting with a rough scratch coat to provide a strong foundation, followed by a smoother coat, and finishing with a finely textured top coat. This process not only ensures durability but also highlights the lime's inherent beauty, creating an elegant look on the stone surface. (Hammoud J., 2022).

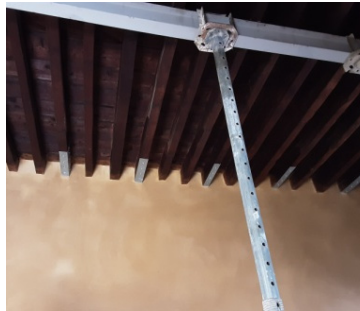
Figure 28. Showing galvanized L-Section plates inside the room (Hammoud J., 2022)

3). Improved Connection with Interior Wooden Ceiling. Interior wooden ceilings are constructed laying girders at short spans of the walls. Timber floors are constructed by placing the floor wooden girders that have a cross section about 15 x 9 cm. The floor girders are put in a row that consists of single layers that are inserted around 13 cm into the walls. The top of the floor girders was covered with the timber flooring boards (20x2cm) perpendicular to them... Tiling is applied at the top of this surface by adding a layer of aggregates. Due to damp and moisture coming from leaking roof or seepage from outer facades that let water straight through to the wall where the girders of the ceiling sit cause attach of biotic agents like fungi. However, the moisture gets there; it travels straight up the end grain and never gets a chance to dry out. The constant moisture is a perfect habitat for wet rot and dry rot. Strengthening the connection between the facade and interior wooden ceilings enhances structural integrity and conserves architectural authenticity. First, repair is typically needed for the end (timber-to-stone masonry connection) of timber beam-floors and unprotected areas that are at high risk. The rotten timber should be removed, and the end of the joist should be treated to prevent further decay. Typically, pairs of "L" section stainless or galvanized steel plates, pre-drilled, are used with standard coach screws [6]. These plates are screwed onto both bottom edges and secured at the ends of the degraded timber girders. They must be long enough to extend into the wall and past the rotten timber, ensuring a firm holds for the screws. The length also reduces the fulcrum effect, minimizing stress on the existing timber. The plates rest in or on the wall, allowing the rotted end to be cut off. For additional stiffness in rows of continuous end repairs, where there are no sound joist ends between, a bolted connection through the plates into the parent joist can be used. (Figure 28 & 29).

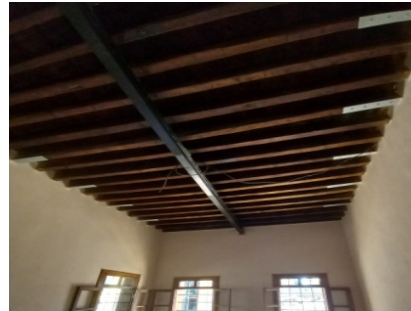
Figure 29. Detail showing the quick and neat solution for joist ends (Hammoud J., 2019)

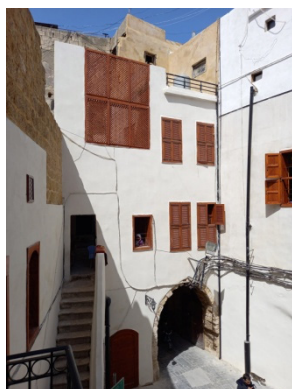
Figure 30. Installing new openings maintaining their coherence and functionality (Hammoud J., 2021)

4). Repair and Installation of Wooden Doors and Windows: Restoring historic windows and doors involves dispelling the myth that new installations, designed to match historic appearances, are always a superior solution. While modern replicas might visually mimic the original designs, they often utilize fast-growing, less durable woods prone to rot and insect damage. This contrasts with the aged hardwoods typically used in historic constructions, which have already proven their longevity. The reality is that authentic restoration, using traditional materials and methods, often results in more durable and historically accurate outcomes. Balancing historical integrity with practical durability necessitates a nuanced approach, prioritizing skilled restoration over simplistic replacement to preserve the true essence and longevity of historic buildings. Given budget constraints, the donor opts for these cheaper replacements, overlooking the long-term benefits of proper restoration. This often leads to a cycle of recurring repairs and replacements, ultimately costing more than investing in traditional restoration methods that preserve both the historical integrity and durability of the building. Replacing historic windows and doors with new ones while maintaining their coherence and functionality involved a meticulous process to ensure seamless integration with the building's historic character (Figure 30). This process included a thorough assessment and documentation of the existing windows and doors, capturing their dimensions and unique design features. Materials were carefully selected to match or closely resemble the originals, such as high-quality wood for the sash, casing, side jambs, and door panels, and single-pane glass to preserve the historic look, with the option of glass improved energy efficiency that mimics single-pane appearance. Custom fabrication was essential to accurately replicate the original profiles and patterns of the sash, muntins, and door panels. Finishing touches, such as historically appropriate paint and accurate hardware, complete the process, ensuring that the new windows and doors uphold both the aesthetic and functional standards of the originals (Figure 31-33).

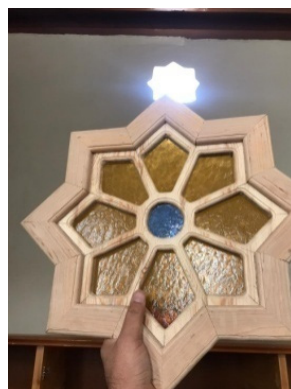
Figure 31. Installing new oculus matching the original design (Asmar P., 2020)

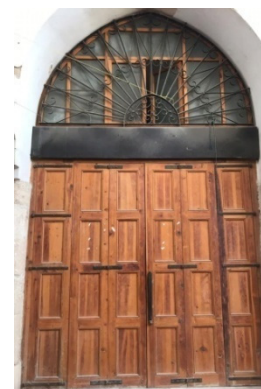
Figure 32. Door panels design for historic market door (Asmar P., 2020)

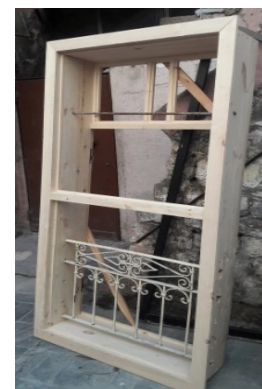
Figure 33. Fabrication of patterns of window casement, sash, muntins, and Iron bars (Hammoud J., 2021)

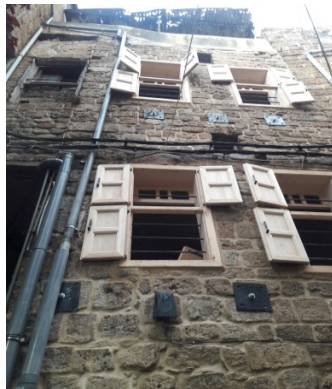
Figure 34. Showing the galvanized plates from outside (Hammoud J., 2019)

are modest, and indeed usually imperceptible, if a serviceable performance is to be achieved [5]. Historic structures in old Saida city are not exempt from this need or from the effect of movement. According to the author’s visual inspection that was straightforward and by using a simple plumb and line level to check the distortion in stone masonry. In this case we noted bulging to the front and main facades, and the distortion showed to be around 65 mm forced outward. The bulging seen was often caused by a number of factors. A lack of lateral restraint which is a well-known principle that lateral restraint should be provided to arrest any potential movement in the stone walls, and this is usually achieved by building floor joist ends into the external stone wall being insufficiently thick. Another factor is the increasing of the floor loads and thermal or moisture expansion of the walls outer surface. This issue happens when massive amounts of water entering the stone walls. The need for strengthening was established. One principle reason for carrying out remedial treatment was to restore the structural adequacy that ensured safety. It was often necessary to incorporate active steelwork as sympathetic strengthening technique that was designed for this case. Opposite parallel walls were held to internal cross walls by pre-stressing bars, the anchoring being done against horizontal steel channels instead of small steel plates. The steel channels running from one cross wall to the other will hold the walls together and improve the integral box like action of the walls (Figure 34 & 35). It was suggested that steel bars to be totally buried under the tiles where the end of steel bars had to be supported in the external walls that may allow the passage of damp or where the steel plate was to be exposed to weather. In this sense, the plate had to be galvanized and powder coated to avoid corrosion problems. Holes drilled in the walls to anchor them had to be filled well with lime mortar.

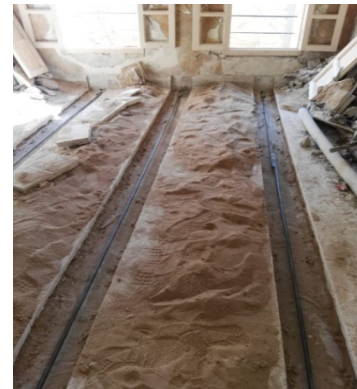
Figure 35. Pre-stressing bars buried under tiles (Hammoud J., 2019)

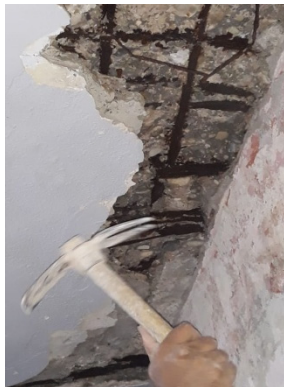
Figure 37. Mechanical removal of concrete cover (Hammoud J., 2021)

7). Repair of reinforced concrete balconies and protrusions: Adding concrete balconies to historic buildings can raise concerns about the structural integrity of the original construction. Historic buildings might not be designed to support the additional weight and stress, potentially leading to damage or the need for extensive reinforcement. Severe exposure conditions cause concrete to deteriorate where carbonation of concrete is a cause of steel corrosion, which may result in aesthetic, functional, or structural problems. Localized patch repairs of areas of corrosion damage are popular due to their low cost and temporary aesthetic relief. Complete removal of chloride-contaminated concrete, where it is possible should successfully halt corrosion by restoring passivating conditions to the reinforcement. Mechanical removal of cover concrete is usually done with pneumatic hammers as seen (Figure 37). Patch repairs consist of several activities that start from the removal of delaminated concrete to fully expose the corroded reinforcement [5,6]. Then cleaning of corroded reinforcement and the application of a protective coating to the steel surface by applying anti-corrosion epoxy coating or zinc rich primer coat is required. Finally, the application of pre-mixed, polymer-modified cementitious non shrink mortar to replace the damaged concrete and giving high performance at plastic consistency [6]. After a thorough inspection for the additional loads the balconies need to support, the author proposed an intervention complying with historical conservation principles and do not adversely affect the building's historical value. Strengthening added concrete balconies in historic buildings using steel brackets is a practical method to enhance the structural integrity while maintaining the aesthetic and historical value of the building. The *steel brackets* with corrosion protection measures are a strong, durable choice to transfer loads from the balcony slab to the stone walls of the building. *Brackets are manufactured based on siding thickness*. As seen in the figure (Figure 38), steel brackets are attached to the concrete balconies by using two methods. The first method involves steel hollow sections fixed on walls by using anchor bolts, epoxy resin directly in the joints to ensure a strong connection without harming the existing stone. The second method involves IPNs fixed directly inside the wall where the voids between the IPN and the stones are filled with lime mortar to avoid additional stress points that could lead to future cracking or failure. By following these steps, you can effectively strengthen concrete balconies in historic buildings using steel brackets while maintaining the structural and historical integrity of the building.
