# Effects of Piers on Water Recession on the Southern Shores of Winam Gulf, Homa- Bay County, Kenya

Piers are important man-made water vessel landing facilities in lakes and seas. A study on the effects of piers on water recession was conducted on the Southern shores of Winam Gulf of lake Victoria, Homa Bay County in Kenya. It was conducted in three pier points namely Kendu Bay, Kowour/Homa Lime and Homa Bay. The study aimed at explaining a phenomenon whereby the Western side of the piers on the Southern shores of the gulf, having more water recession than on their Eastern side. This unique phenomenon has not been sufficiently researched on hence, instigated the research. It collected data on the length of recession at the sides of the piers, directions of water currents flow based on devised simple current simulator and empirical studies. Google map and Landsat map techniques were used for aerial data collection. Ground truthing was carried out to corroborate the findings of the aerial data based on physical ground measurement and observation. The result had it that the sides of the piers facing currents directly were more recessed than the opposite sides. Homa Bay pier had its W

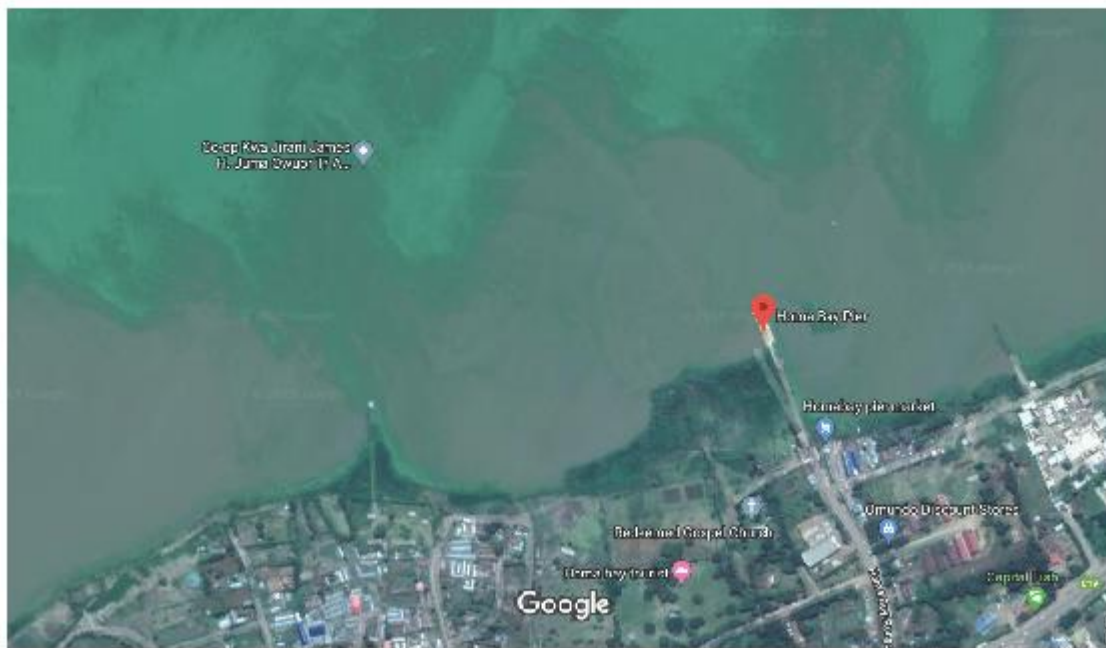
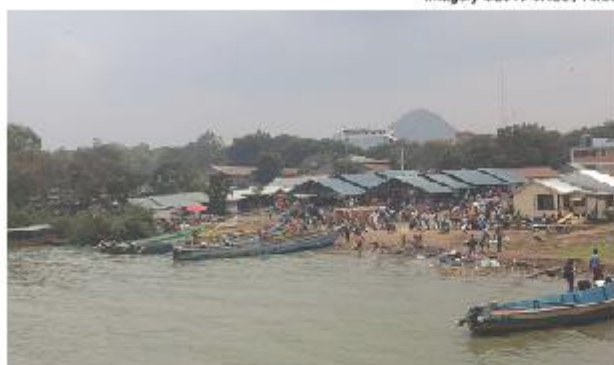
Figure 3. Google (Landsat) map data for Homa Bay pier at the center and other small piers; Shauri Yako to the left and Capital fish pier to the right as at 29<sup>th</sup> September, 2019

Figure 3 (Landsat data) above shows the main pier at the center of the shore. A small pier to the right side of the main pier which was mainly used by the defunct Capital fish industry to dock their boats is also observable. To the left of the main pier at the center, stands another pier which is the water pumping plant for Homa Bay town located at Shauri Yako estate. The ground distance between these piers were approximately 150m and 200m from the main pier respectively. A keen observation of the Landsat data (Figure 3) reveals that recession occurred in both sides of the piers but it was greater on the main pier as compared to the other two. A further keen observation of the piers (Figure 3) shows that the western side of the main pier at the center is more recessed than the Eastern side. However, the pier hosting the water pumping plant for Homa Bay to the left side of the main pier is more recessed on the Eastern side than on the Western side (Figure 3). Google map (terrain) in figure 4 shows the same observation but only on the central main pier since the other two piers were too small to be identified. Ground truthing was carried out on the main pier (plate 1) and also reveals the same findings as the Landast data (Figure 3).

Despite the North-South orientation of the small water pumping plant pier for Homa Bay at Shauri Yako estate on the Western side of the Homa Bay main pier (Figure 3), the Eastern side of the pier was more recessed as compared to the Western side. The cause of variation of the sides of the Homa Bay piers recession was attributed to the flow of water currents. On the main pier, the simulator was deflected Eastwards on average an indication that water currents were skewed Eastwards resulting to more deposition at the Western side of the pier. In contrast, around the small water pumping plant pier at Shauri Yako estate, the simulator was deflected Westwards in average, thus, currents were skewed Westwards leading to more deposition of sediments at the Eastern side of the pier causing recession. This finding is in congruence with the findings of Jason et al. (2005) which shows that currents in the Southern section of Winam Gulf flow into Homa bay in a South-East direction then breaks into East-West direction few meters to reaching the shoreline (Figure 7).

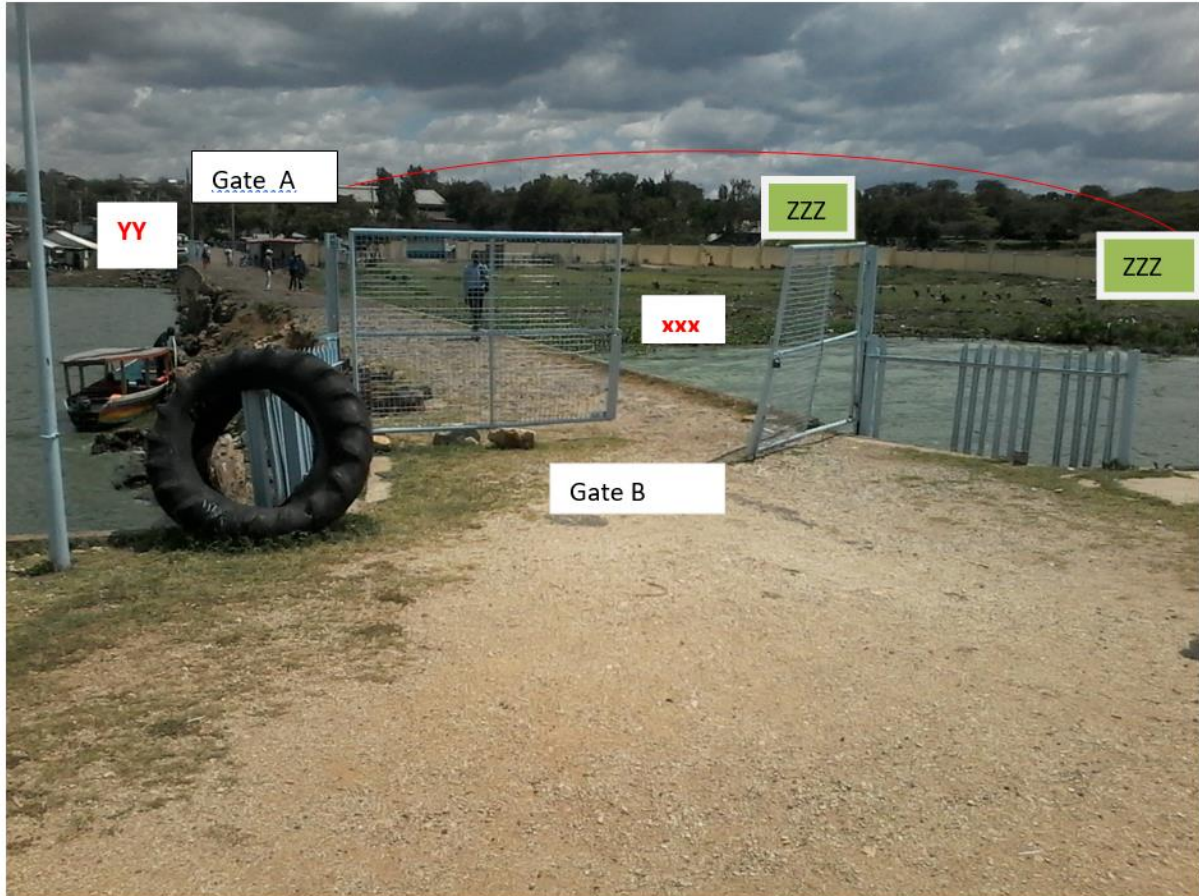
Plate 1. A ground general view photograph of Homa bay pier showing the variation on the shore line water level on both sides of the pier

**XXX**- Beginning of water level from the land on the Western side of the pier after recession.

**YY**- Beginning of water level from the land on the Eastern side of the pier after recession.

**ZZZ** - Recessed land

Gate A- The first gate from the mainland marking the initial water level on both sides of the pier.

Gate B- The second gate from the mainland.

The variation in width of recession between gate A which was used as reference point from the main land and point marked **XXX** was 40m (Plate 1). The distance between gate A and the point marked **YY** was 2m (Plate 1). There were so many scavenging birds of various species on the Western side of the pier but this was a matter of

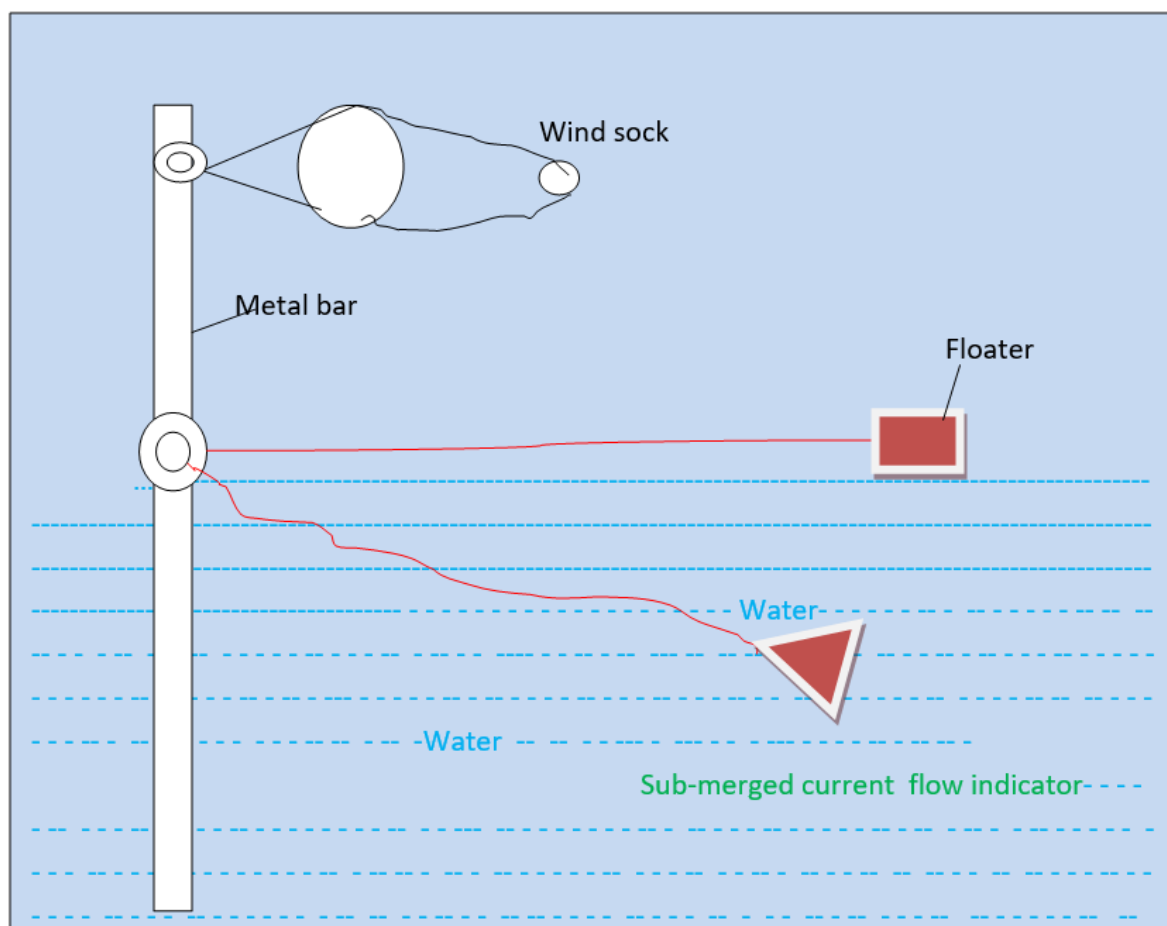
Figure 5. An illustration of the devised simple current flow simulator. Direction of deflection of the floater and the submerged current flow indicator show the direction of water currents.

The average direction duration (Hours in a day) of flow of water current (turbulent flow) was recorded on a 'current rose.' The current rose worked on the principle that as the currents move, they deflected the floater and the semi-buoyant; partially sub-merged indicator along their direction. This indicated the movement of sediments (materials) dragged by water. This study was mainly concerned with the direction and duration of the turbulence flow in the southern part of Winam Gulf. Nevertheless, Jason et al. (2005) had an elaborate study of flow of water in the Winam Gulf and Rusinga Channel. They found out that more water flows from the main lake into the gulf and pressure at the main lake was higher than at the gulf hence more flow into the gulf than the reverse direction. They attributed the inflow into the gulf to the Westerly currents and outflow from the gulf to the Easterly currents. Unlike studies by Jason et al. (2005) which elaborately investigated the causes of the turbulence flow such as water temperature, pressure gradient, depth, velocity, duration and direction of flow, this study only investigated the direction and duration of the flow of currents on the Southern shore of Winam Gulf, Homa bay County piers, Kenya.

The result from the devised simple current flow simulator (Figure 5) is recorded in a 'current rose' in figure 6. From the figure, currents were mainly skewed Eastwards and Westwards attributed to the Easterlies and Westerly currents (Jason et al., 2005). These currents were responsible for deposition of sediments and retention of aquatic weeds on the sides of the pier. Since the flow was more skewed towards East (Figure 6), due to strong Westerly currents, the Western side of the shore was more recessed than the Eastern side (Figure 2 and 3). The East-West recession on the sides of the piers were only particular to Kendu Bay and Homa Bay (main) piers which lie North-South direction with the shore line.

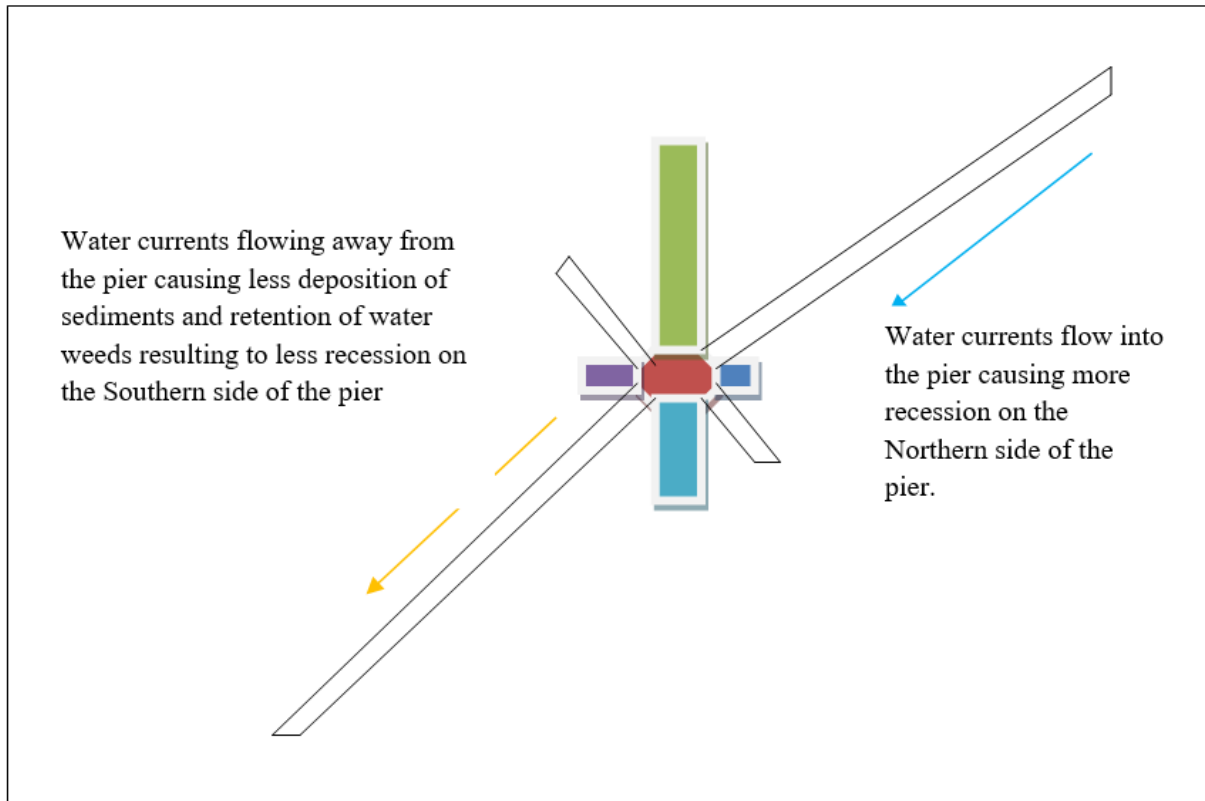
Figure 8. Current rose for Kowuor/Homa Lime pier showing direction of the prevailing currents' flow  
 Source: Researcher, (2019c)

From figure 8, it is explicitly clear that water currents flow were skewed North –South wards as was deflected by the devised simple current simulator. The Southern skewed currents were responsible for more recession on the Northern side of the pier. In contrast, currents on the Southern side of the pier that originated from the pier point and flew South West wards were responsible for limited recession on the same side of the pier.

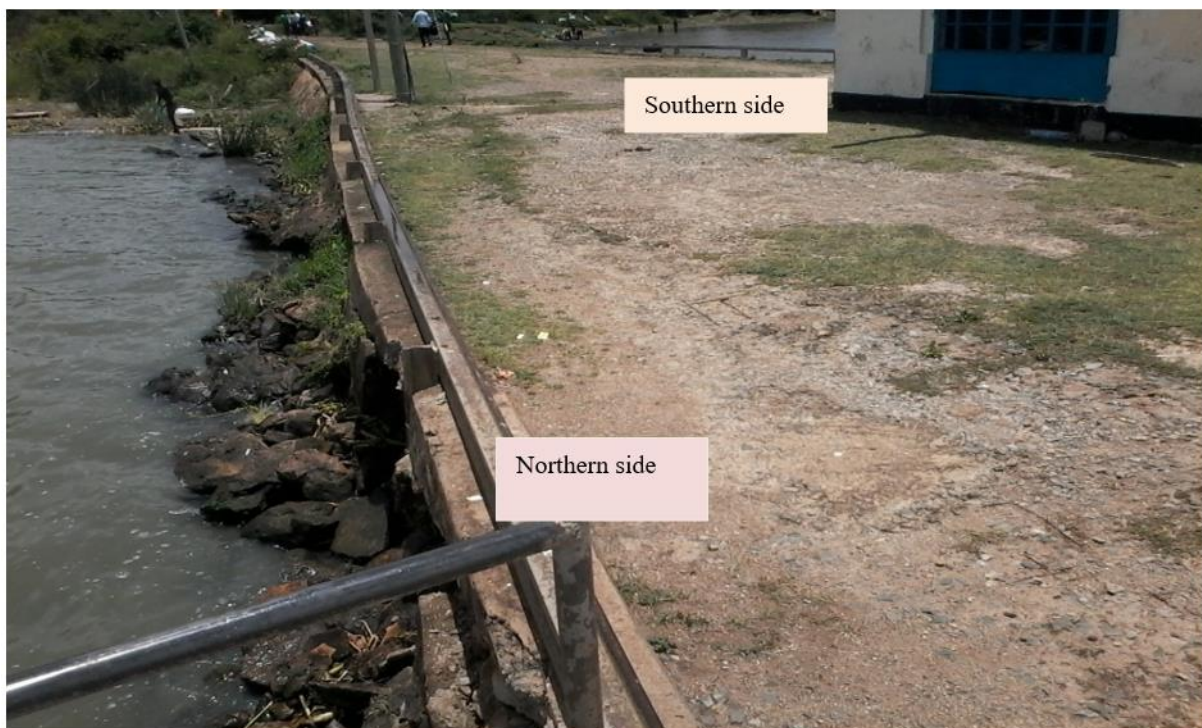
Plate 2. Water recession at Kowuor/Homa Lime pier

The Northern side of the pier was 32m more recessed than the southern side (Plate 2). This was attributed to the position of the pier in relation to other piers under the study and change of currents direction from West-East (W-E) to North-South (N-S) orientation. The N-S current orientation was attributed to more recession on the Northern side of the pier as compared to the Southern side. At Homa Bay pier (second longest), the difference in variation of water level at both sides of the pier was 40m. At Kendu Bay which was the longest pier, the study could not empirically establish the difference of the variations of water levels at the sides of the pier. This was because of the drenching activities carried out by the Kenya Ports Authority (KPA) at the time of the study, nevertheless, the Landsat data and Google map (Figure 1,2,3 and 4) explicitly showed that the Western side of the pier was more recessed than the Eastern side as per 29<sup>th</sup> September, 2019 when the data was taken.
