Effects of Changes of Lake Victoria Water Levels on Land Use Patterns, Covid-19 Pandemic and Food Security in Winam Gulf, Homa-Bay County, Kenya

Otieno, J.¹ & Otieno, A. C.¹

¹Department of Geography and Social Sciences Jaramogi Oginga Odinga University of Science and Technology, Bondo, Kenya

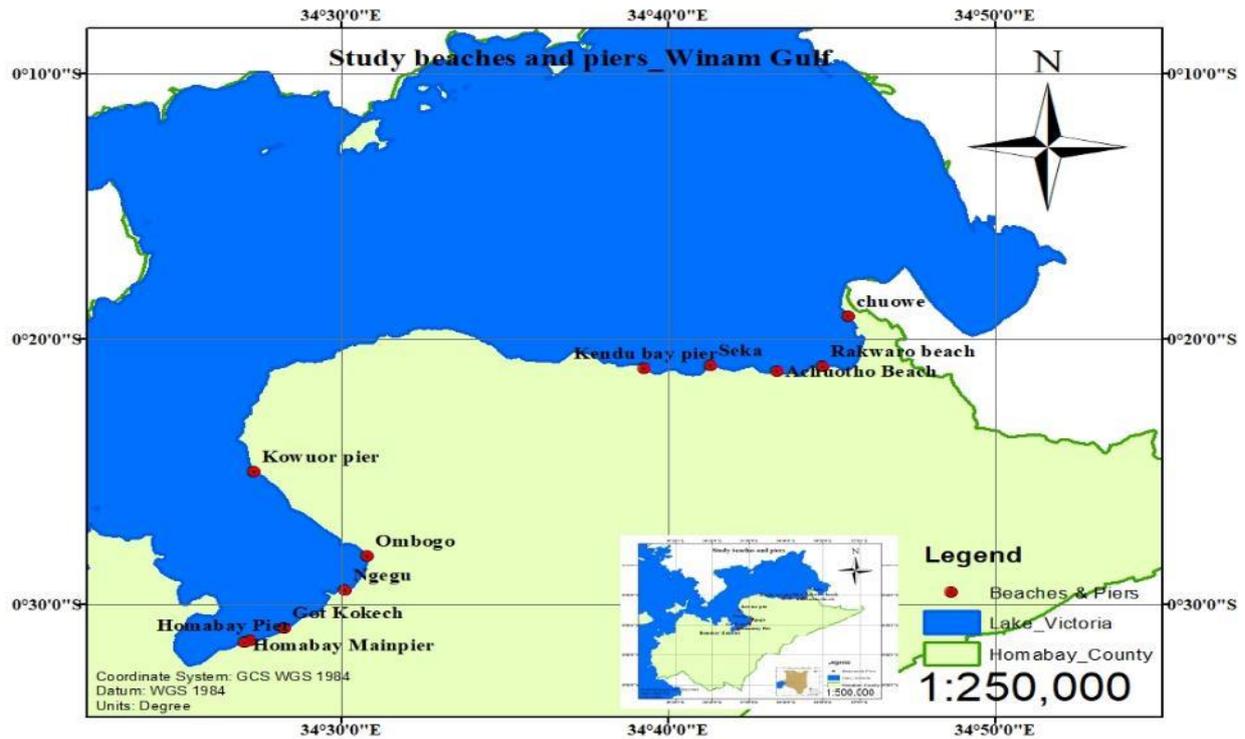
Figure 3. Map showing the location of the data collection points for the study

The first survey points were sited at five pier points where the vertical variations of water levels at the pier sides were determined using a hand tape measure between July 2019 and October 2020. Three out of the five study points were sited at the sides of the main piers at Kendu-Bay, Kowuor and Homa-Bay piers. The other two study points were located on the small boat landing piers located at Achuotho beach near Kendu-Bay and on the Capital Fish landing pier next to Homa-Bay main pier.

The heights of the five piers were measured regularly from the top of the piers' rail guards exposed over water. The original measurements of the heights of the hanging pier's side rail guards were taken as from July, 2019 and recorded. Subsequent measurements, readings and recording of the changes of the heights of the rail guards were carried out regularly until the end of the back flow which was characterized by plateauing of flooding of the shore land and gradual retreat of the lake waters. The Changes in the Level (CL) of the lake's waters were obtained by subtracting the average New Minimum Overhanging Height (NMOH) from the Original Overhanging Height (OOH) of the rail guards at the side of the piers. That is; CL=OOH-NMOH. The measurements were taken at different positions (sides of the large piers and on top of small low-end piers) (Figure 3) so as to corroborate and authenticate the findings.

Lateral spread of the back flow was defined as the horizontal distance on the ground under flooding by the lake's waters. It was determined from nine survey points (Figure 3) located at different elevations on the shore line using point measurement with the aid of a surveyor's foot measure. The research relied on physical land marks before the back flow such as mangrove and other trees species and human made features like abandoned boats, steamers and buildings at the point where water levels reached during the last recession. From these points, measurements, readings and recording of the spread of the back flow and flooding of the shore were taken. Other aspects of data that were obtained from the respondents through interviews and questionnaire administration were analyzed using descriptive statistics and Likert's Scale 1-5 based on Effective Perception Index (EPI) and Summative Effective Perception Index (SEPI).

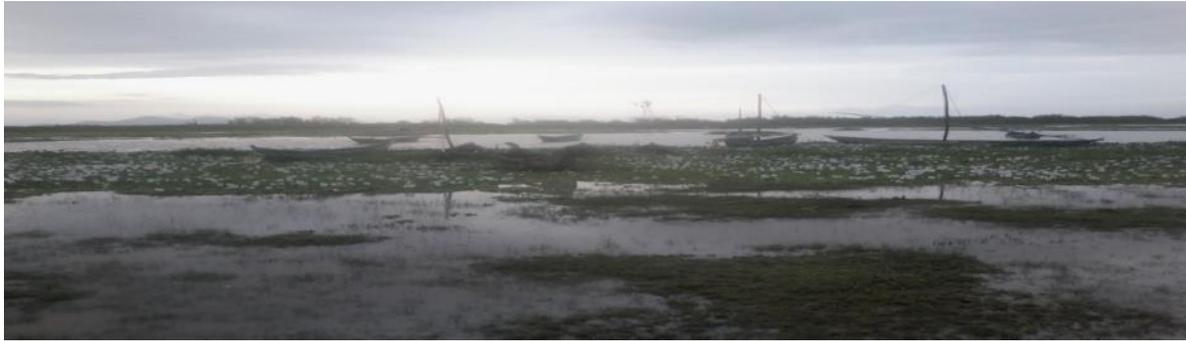
Plate 1. Change of land use pattern from grazing land to fishing/beach by March, 2020

The land use activity shown in Plate 1 is currently fishing but was previously a grazing land before the back flow phenomenon.

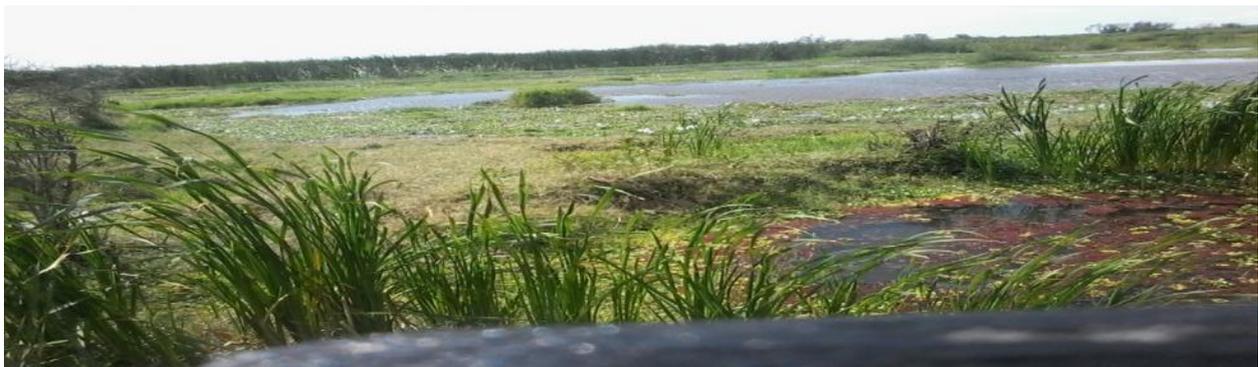
Plate 2. Change of land use pattern from farming and sand excavation to papyrus reeds vegetation during back flow by October, 2020

The emergence of vegetative cover along the shore line blocked fishing beaches causing accessibility and docking challenges to fishermen.

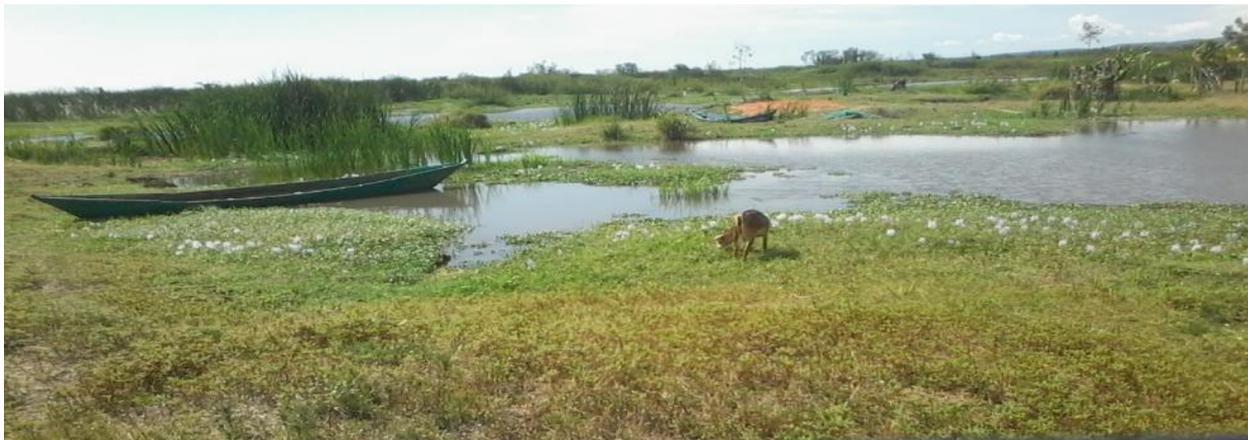
Plate 3. Mixed land use pattern caused by back flow

In Plate 3, the lake is in the dead ground 200m away and is blocked by vegetation in the background. In the center middle ground, lies boats and a fish net indicating fishing activity in the area. In the right middle ground of Plate 3.3, are banana crops while in the center foreground is a goat grazing. Water bodies in the middle ground were previously sand excavation sites before the back flow.

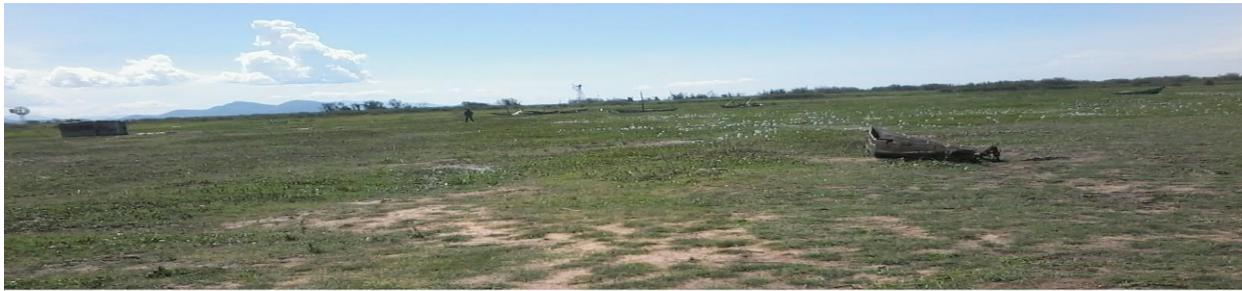
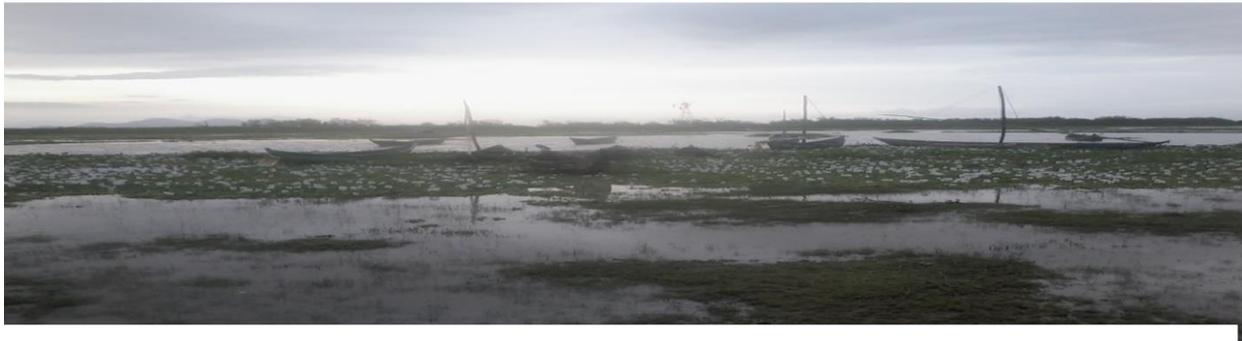
Plates 3.4(a and b): Gradual changes of land use patterns from fishing (beach) back to grazing land

a) Peak of the back flow by March, 2020.

b) Recession of the back flow by October, 2020.

Source: Researcher, (2020) kindly delete. Seven months after the peak of the back flow and consequent flooding of the shores of Winam Gulf, near Ombogo beach (Plate3.4b). Water level receded and the original land use activity (grazing land, Plate 3.4b) was gradually reclaiming its place. Fishing activity (beach) declined as water level reduced and boats could not anchor (Plate 4b), hence the boat owners shifted to other beaches except the few boats shown in the middle ground of Plate 4b. At this survey point, the lake’s waters had receded by approximately 100m from May, 2020 when it was at its maximum width of 500m (Table 2). In the Plates 4 (a and b), the main lake is in the dead ground on the left side.

Nevertheless, after May, 2020, water levels began to retreat gradually and some parts of the shore which were deserted during the peak of the back flow were resettled. Plates 4 (a) and (b) explicitly show the change of water levels and land use patterns during the peak of the back flow in May, 2019 and afterwards in October, 2020 in one of the shore lines.
