Analysis of the Factors Influencing the Changes in Beach Landforms of Weizhou Island and Environmental Protection

Abstract

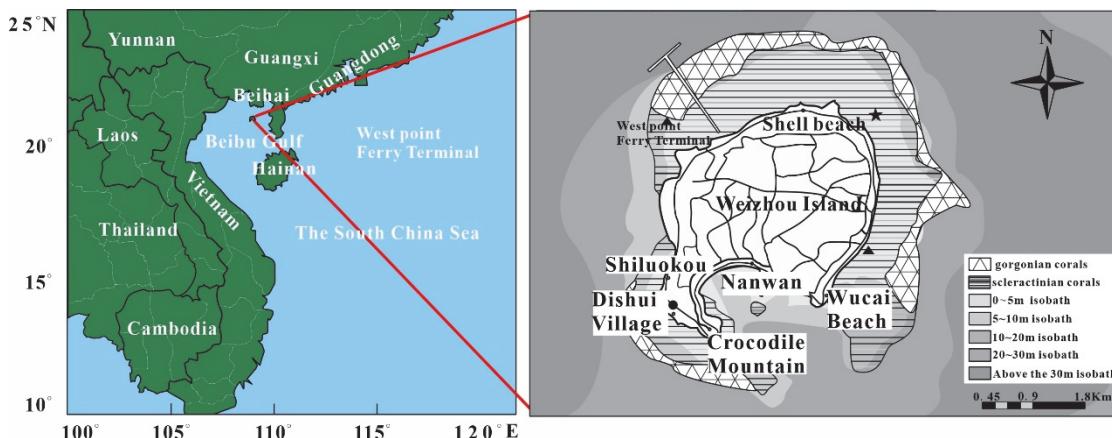
Figure 1. Location and Coral Reef Distribution of Weizhou Island (He et al., 2019)

(a) Star: Coral coverage greater than 20%;(b) Triangle: Coral coverage between 15% and 20%;(c) Circle: Coral coverage between 10% and 15%.

A large number of coral reefs have developed in the shallow waters around Weizhou Island (He et al., 2019; Huang et al., 2009) (see Figure 1, right). Bleached coral skeletons are more easily broken down by waves, tidal currents, and storm surges, transported to the shore, and become the primary source of sand on the beaches of Weizhou Island. In addition, calcareous coralline algae, calcareous foraminifera, and mollusks such as shells and snails are also important sources of calcareous sediment (Yu et al., 2004). These skeletal remains of marine organisms, after mechanical fracturing and abrasion, form calcareous beach sand with varying degrees of roundness and sorting. Coral reefs can absorb wave energy, effectively protecting the coast from erosion and playing a crucial role in coastal protection.

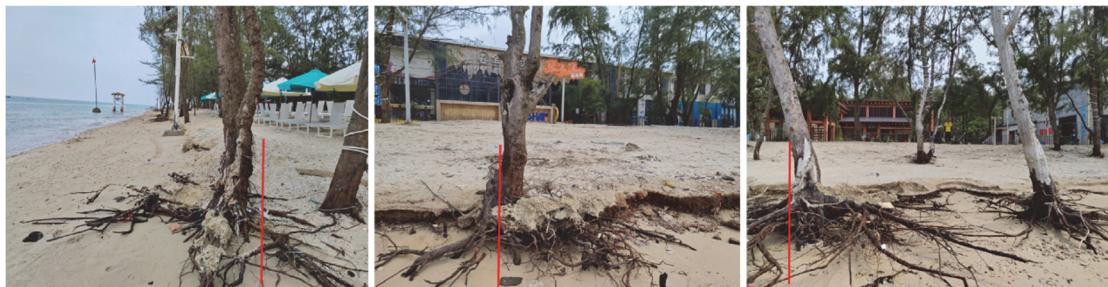
Figure 2. Exposed Tree Roots on Dishui Village Beach After Erosion by Storm Surges (Photographed on 2024.9.17)

After Typhoon "Capricorn" made landfall on Weizhou Island on September 6, 2024, the beach at Dishui Village also suffered severe erosion. The original gravel embankment, which had been raised above the beach, completely disappeared. The front-row protective forest, which was closest to the sea, suffered intense disturbance, with the exposed tree roots reaching a depth of 0.6 meters (Figure 2), causing some trees to fall. This occurred because the tropical storm, which passed through the South China Sea and entered the Beibu Gulf from south to north, struck the beach at Dishui Village on the southwestern tip of the island. Due to its direct exposure to the typhoon, the storm's erosive effect on the beach was more intense, with large amounts of sediment being transported away, and the previously massive gravel embankment (the coastal berm) disappearing. The front-row trees lost their original protection.

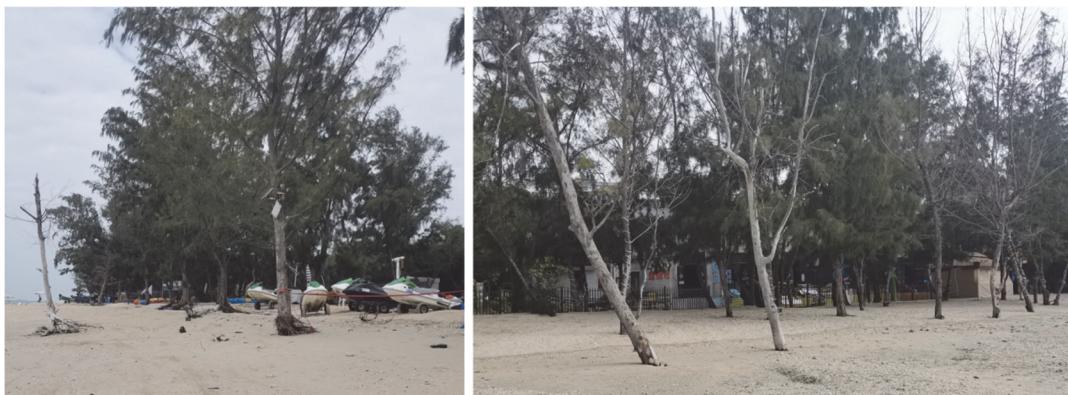
Figure 3. Part of the Vegetation on Dishui Village Coast Has Wilted or Even Died (Photographed on 2024.12.17)

Even three months after Typhoon "Capricorn," although most of the previously exposed tree roots were buried again, some tree roots were still exposed, with the exposed height reaching up to 0.3 meters, and some trees were completely dead (Figure 3). A closer inspection revealed that the leaves and branches of the front-row trees facing the sea were generally more yellowed, indicating poorer growth compared to those in the back row, which had not been exposed to storm surge erosion and whose roots had not been exposed.

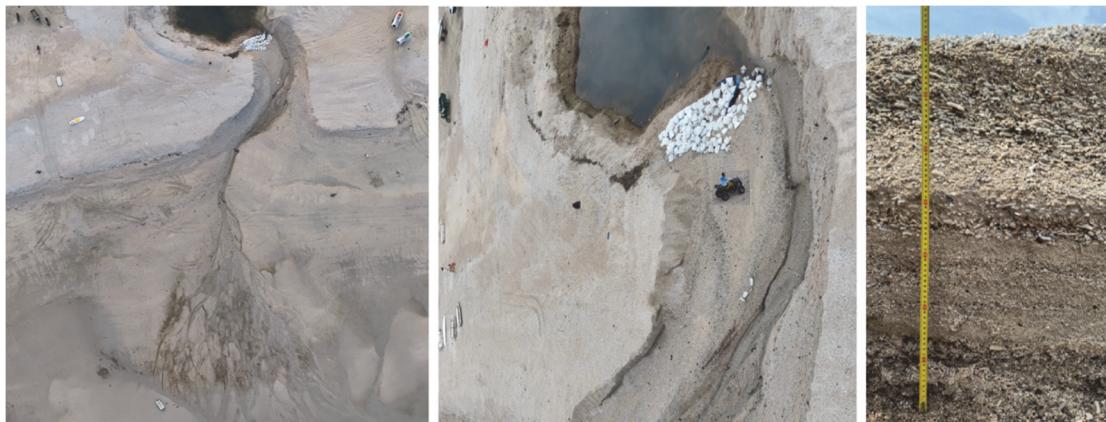
Figure 4. Formation of a Large Erosion Trench in the Dammed Lake at Shiluokou Due to Storm Surge
(Photographed on 2024.9.16)

Storm surges also affect the geomorphology of Shiluokou Beach. After Typhoon "Capricorn" made landfall on Weizhou Island, a large deep trench appeared along the coral gravel embankment (the coastal berm) behind the beach (Figure 4), with steep cliffs reaching up to 70 cm in height.

There was originally a small stream flowing through Shiluokou Beach into the sea. With the formation of the coastal berm, the outlet of the stream was blocked, creating a small dammed lake (Chen et al., 2024). When a storm surge arrives, or during extreme tidal high water periods, the tidal flow carries a large volume of seawater over the berm and into the dammed lake. Once the water level in the lake becomes too high, the volume and energy of the outgoing tidal flow exceed the capacity of the dam, causing a breach in the berm. After repeated erosion from the powerful storm surges, a large trench is formed, allowing the water from the dammed lake to flow back into the sea, thus reviving the stream on the beach.

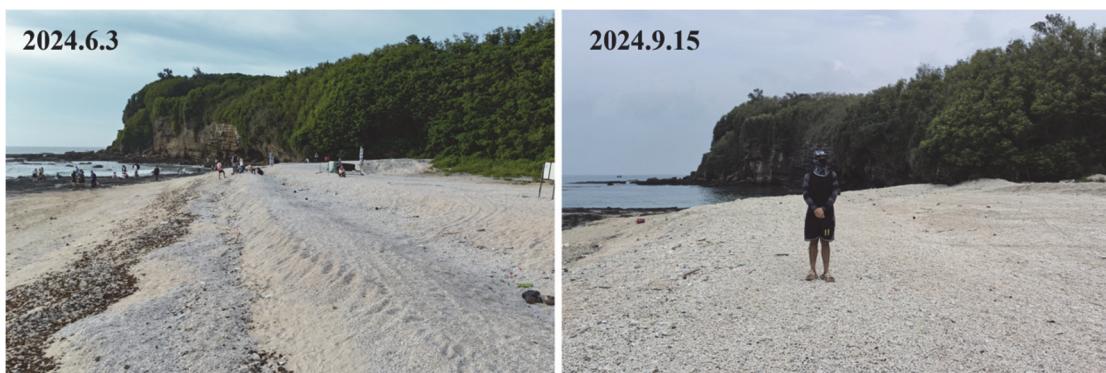
Figure 5. Comparison of Coral Gravel Embankment Development at Shiluokou Cape Before and After Typhoon

After Typhoon "Capricorn" made landfall on Weizhou Island on September 6, 2024, the author conducted another investigation. Comparing photos of the coral accumulations on the beach taken from the same angle before and after the typhoon (Figure 5), it was observed that after Typhoon "Capricorn," the coral gravel embankment had accumulated on a much larger scale. The embankment expanded further toward the sea and north, with a noticeable widening. The changes in the beach geomorphology near the cape were quite significant.

As mentioned earlier, when the typhoon made landfall on Weizhou Island, large amounts of sediment eroded from the Dishui Village beach were transported northward by the storm surges. Upon reaching Shiluokou Beach, these sediments were largely deposited on the southern side of the cape due to the blocking effect of the cape. The

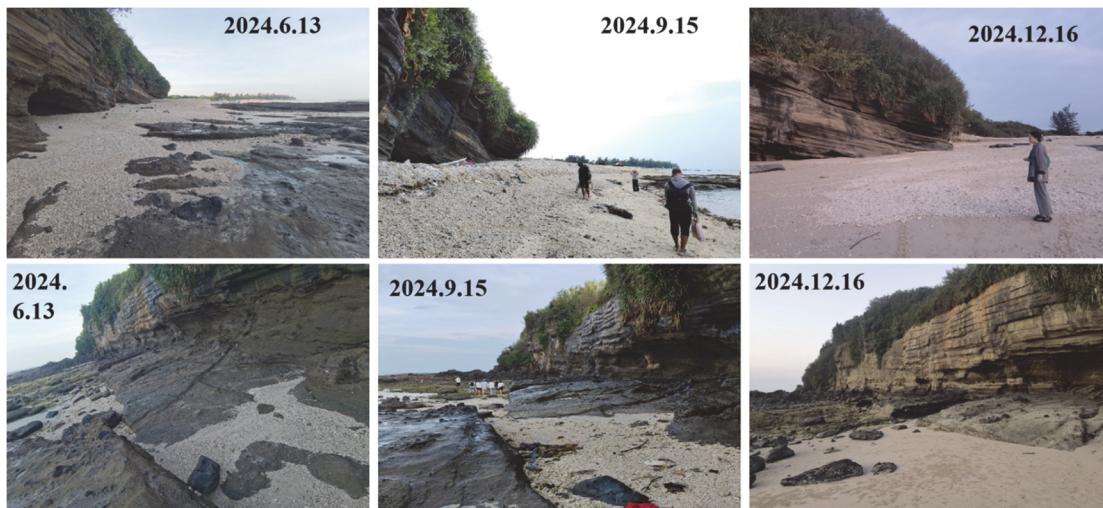
Figure 6. Migration of Sand at Shiluokou Beach. Top row: Photos taken towards the south; Bottom row: Photos taken towards the north

Multiple field surveys have revealed that the beach sediment at Shiluokou Beach, Weizhou Island, appears to be migrating northward along the coastline. To verify this observation, the author conducted fixed-point photography at two locations with similar beach sediment distribution under the cliffs to the north of the Shiluokou Cape over a period of six months (Figure 6). A comparison of six photographs from three sets clearly shows that the beach sediment beneath the cliffs at Shiluokou Beach has indeed expanded noticeably to the north. This continuous northward expansion of beach sediment has significantly altered the coastal landforms.

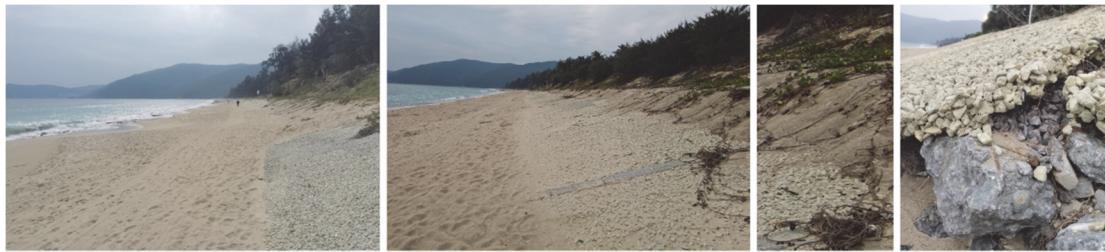
Figure 7. Series of Photos of the Ecological Protective Slope Project at the Western Section of Yalong Bay
(Photographed on 2024.12.16)

The newly constructed ecological protective slopes at Yalong Bay's western section consist of three layers (Figure 7, left 1-3): the lower layer is a concrete structure, the middle layer is a salt-tolerant marine snail ecological slope, and the upper layer is a protective forest ecological slope. The concrete structure of the protective slope also consists of three layers (Figure 7, right 1): the base is composed of large stones, the middle is a gravel leveling layer, and the top layer is a concrete surface layer made of gravel. The surface gravel is coated with paint, and the chosen color closely matches that of the beach sand.

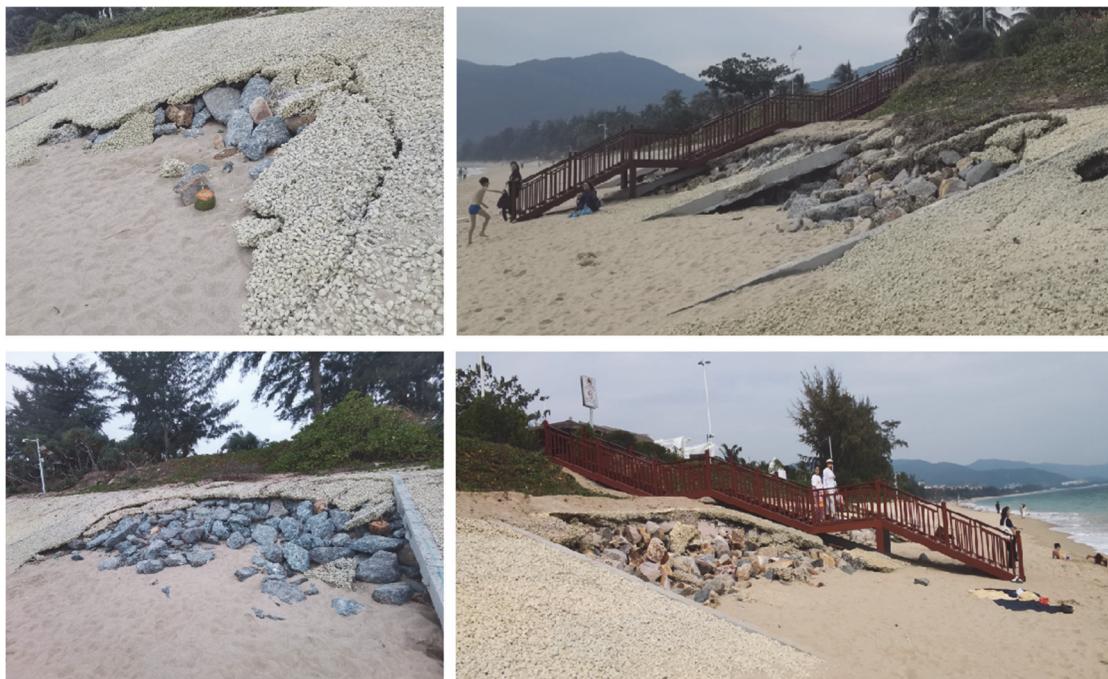
Figure 8. Series of Photos Showing Damage to the Protective Slope Project (Photographed on 2024.12.16)

However, the concrete protective slope is not a permanent solution. Continuous wave erosion, along with material degradation, design flaws, and quality defects, can cause the structure to deteriorate (Figure 8). If small holes are not repaired, they will inevitably lead to larger cracks that are harder to fix.

(3) Reasonably Establish Coastal Protection Projects: Learn from the experience of the Yalong Bay coastal protection project. Based on the tidal, wave, and current dynamics around Weizhou Island, especially design a reasonable coastal protection project for Dishui Village. Ensure the quality of construction and include local materials, such as coral branches and shells. Timely maintain and repair damaged protection structures.
