# Underwater Access Door System for Tidal Power Generation

Xiaonan Miao<sup>1</sup> & Jia Li<sup>1</sup>

<sup>1</sup> Mechanical department, Lindong New Energy Technology Co., Ltd, Hangzhou, Zhejiang, China

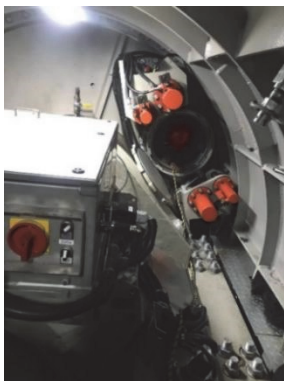
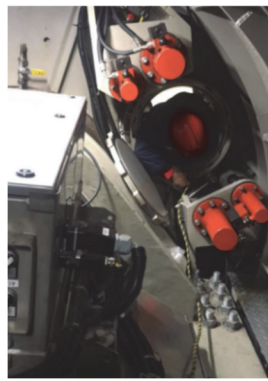
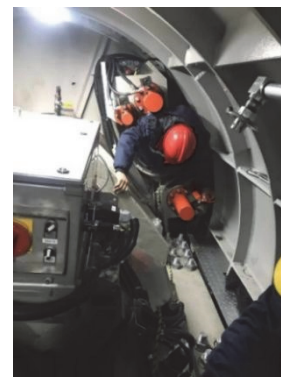
Figure 6. Entering process 1

Figure 7. Entering process 2

Figure 8. Entering process 3

Since its operation in January 2022, the system has been turned on about 70 times, and the overall operating condition is good with no water leakage, as shown in Figures 6, 7, 8 and Table 3.

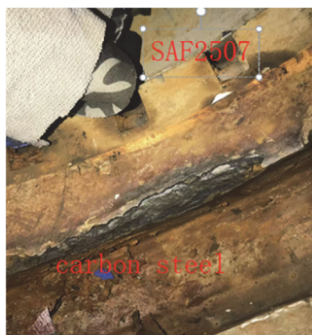
Figure 9. Running for 2 years (sharp points)

carbon steel had severe corrosion, with a pit depth of about 5mm and a length of 70mm, far exceeding that of only carbon steel. Moreover, the corrosion was more severe in sharp areas than in flat areas, while duplex stainless steel SAF2507 had almost no corrosion, as shown in Figures 9 and 10.

After analysis, it is believed that the primary battery composed of duplex stainless steel SAF2507, carbon steel, and electrolyte seawater caused electrochemical corrosion [6], greatly accelerating the corrosion of carbon steel. At the same time, due to the phenomenon of discharge at the tip [7], the corrosion in sharp areas is more severe than in other areas. The solution is to apply a protective coating near the welding area (Figure 10) to isolate them from seawater and prevent electrochemical corrosion, thereby reducing the corrosion of carbon steel [8]. When operating, it is necessary to first clean the sediment and iron filings in the corroded area, then apply quick drying glue, and wait until it is completely dry before retracting the temporary channel. After one year of operation after repair, no corrosion phenomenon was found (Figure 12). Another way is to sacrifice the anode and zinc block for this type of welding, which can avoid corrosion of carbon steel. However, it needs to be welded in advance during installation in the factory. Currently, the space here is narrow and there are many electrical equipment, making it unsuitable for welding.

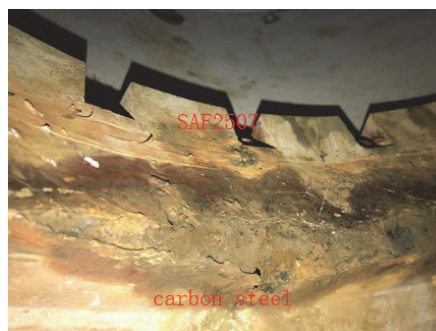
Figure 10. Running for 2 years

Under normal circumstances, the corrosion rate of carbon steel in seawater is about 0.05-0.15mm/yr. After 2 years of operation, in early 2024, it was discovered that the welding joint between duplex stainless steel SAF2507 and
